UNITED STATES ENVIRONMENTAL PROTECTION AGENCY

Re: Town of Brookhaven
SPDES Permit No. NYR20A411

This is in reference to the United States Environmental Protection Agency's (USEPA) Region 2, MS4 Compliance Evaluation Inspection (CEI) at the subject facility on April 12 thru April 28, 2011. This inspection report will be referenced as an addendum to EPA's MS4 Audit conducted on June 7-9, 2011. The Town of Brookhaven is in non-compliance with Part VII.A6 of the New York State Department of Environmental Conservation SPDES General Permit For Stormwater Discharges from MS4 under Pollution prevention/Good Housekeeping for Municipal Operations-SWMP Development/Implementation.

MS4 Inspection Report/Town of Brookhaven (NYR20A411) – April 12-14, and 25-28, 2011

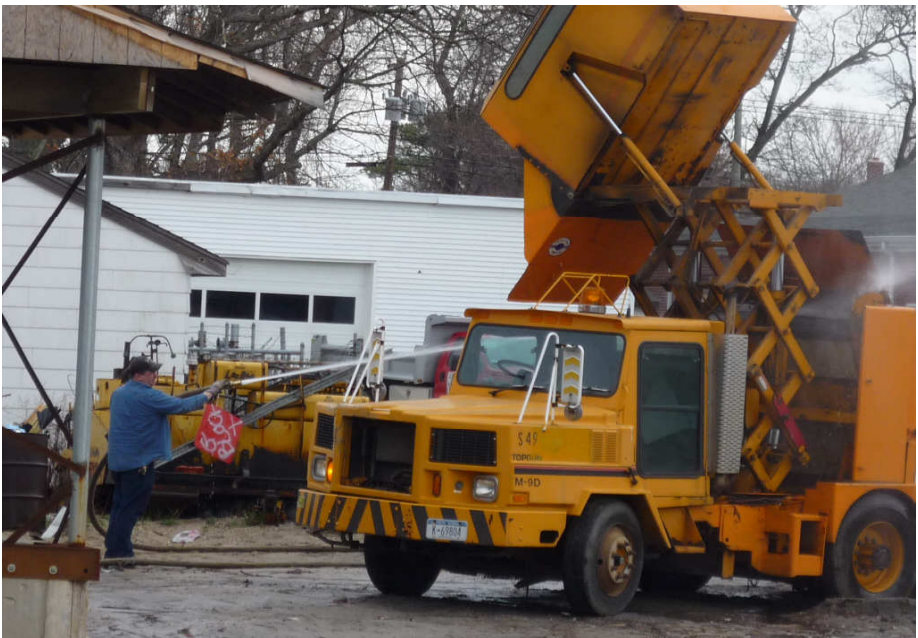
001 Old Town Road Coram

Town of Brookhaven, NY (Unedited photos taken by Jerry Ciotola, Environmental Engineer, USEPA Region 2, Water Compliance Branch, April 12-14, 25-28, 2011)	
Photograph No.	Photograph Description
001	Inadequate salt storage shed/erosion tracks
002	Vehicle washdown outside maintenance shop
003	Unprotected stock piles/salt eroding from shed
004	Liquid from vehicle wash down into drain
005	Oil & grease sheen from vehicle wash down to drain
006	Oil & grease sheen from vehicle wash down to drain
007	Sand and cold patch stockpiles
008	Inadequate salt storage shed/erosion tracks
009	Vehicle washdown outside maintenance shop
010	Spent drums unlabeled and stored in yard (some corroded)
011	Spent drums unlabeled and stored in yard (some corroded)
012	Oil sheens/tracking throughout garage facility
013	Oil and grease tracking offsite
014	Vehicle washdown area/oil & grease stains evident from mixers entering drain
015	Septic condition in dry well

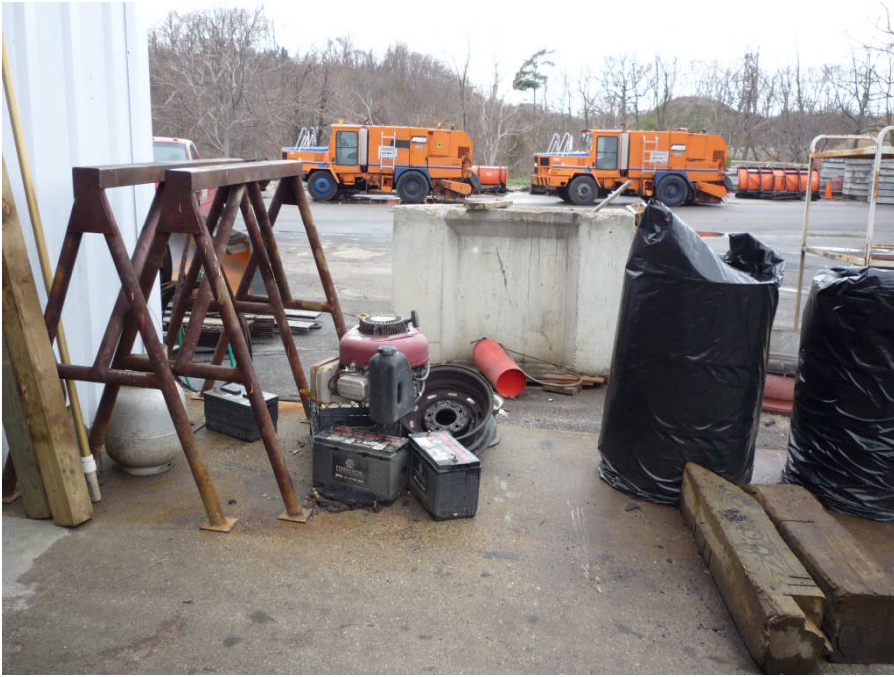
016 Old Town Road Setauket

016	Lubricants stored outside maintenance shop
017	Truck batteries stored outside maintenance shop
018	Unmarked decaying drums outside maintenance shop
019	Unmarked decaying drums outside maintenance shop
020	Truck batteries and unmarked drums stored outside maintenance shop
021	Unprotected stock piles/ salt eroding from shed
022	Salvage storage
023	Sodium ferrocyanide discharging to adjacent drywell.
024	Unbermed cold patch (asphalt) eroding into drains
025	Unprotected stockpiles/erosion
026	Unprotected stockpiles/erosion
027	Unprotected stockpiles/erosion
028	Unprotected stockpiles with mixed debris and garbage
029	Unprotected stockpiles with spent asphalt
030	Spent gasoline jugs, cans & solvents unmarked
031	Unprotected stockpiles/erosion offsite
032	Unprotected asphalt stockpile
033	Storm water carrying solids and sediment directed to a pocket wetland
034	Oil sheens to drain
035	Oil sheens to drain
036	Single-walled #2 fuel oil tank, no secondary containment
